Electrical measurements on adjustable speed drives

Ten measurements that tell you a lot

Application Note

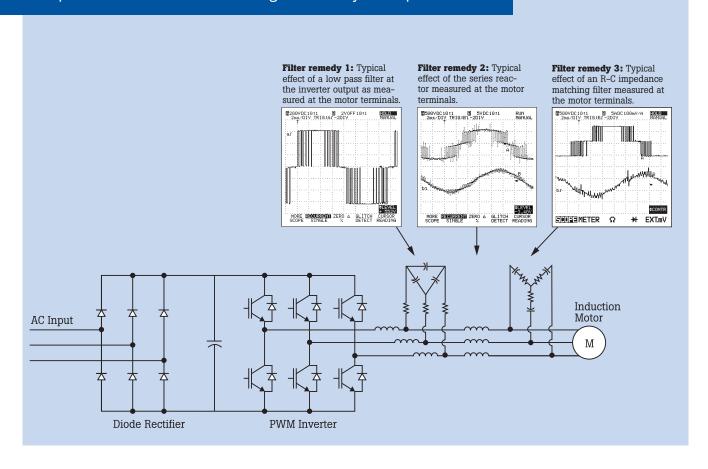
Inverter Output Filter Remedy 1	Series Reactor Remedy 2	Motor Terminal Filter Remedy 3
Series connected to the PWM output terminals.	Series connected to the PWM output terminals.	Parallel connected at the motor terminals.
Designed to slow rise time (dv/dt) below a critical value.	Acts as a current limiter and also slows rise time.	Designed to match the characteristic cable impedance.
Dependent on cable length.	Dependent on size of system.	Not cable length dependent.
Losses dependent on motor kVA.	Losses dependent on motor kVĀ.	Losses are more or less fixed.
Size/cost dependent on motor kVA.	Size/cost dependent on motor kVA.	Size/cost more or less fixed.

If the cabling in your PWM application cannot be shortened then use one of these three solutions to fix the problem.

- An external "add-on" low pass filter can be installed between the PWM output terminals and the cable to the motor to slow the rise time.
- Install an R-C impedance matching filter at the motor terminals to minimize the overvoltages, or ringing effect.
- 3. In some applications, such as submersible pumps or drilling machines, it isn't possible to access the motor terminals and other methods of minimizing overvoltages are required. One method is to apply series reactors between the PWM output terminals and the cable to the motor. While this is a fairly simple solution, the reactors may be fairly large, bulky and expensive for large horsepower applications.

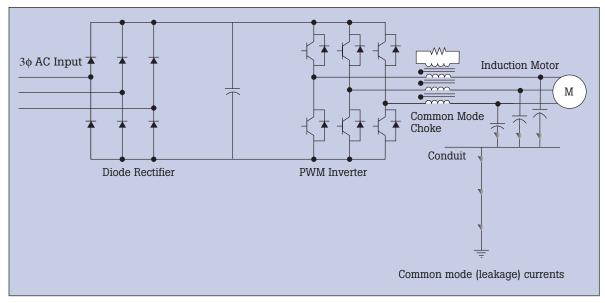
Figure 5A. Common mode choke with dampening resistor to reduce leakage currents.

A common mode choke can be used to reduce leakage currents (see Figure 5A). Also, special EMI suppression cables can be used between the drive output and the motor terminals. The copper
